REPORT NUMBER 301L-GTL-03-003

**SAFETY COMPLIANCE TESTING FOR
FMVSS NO. 301L
FUEL SYSTEM INTEGRITY**

**FORD MOTOR CO. IN U.S.A.
2003 FORD ESCAPE MPV
NHTSA NO. C30206**

FINAL REPORT

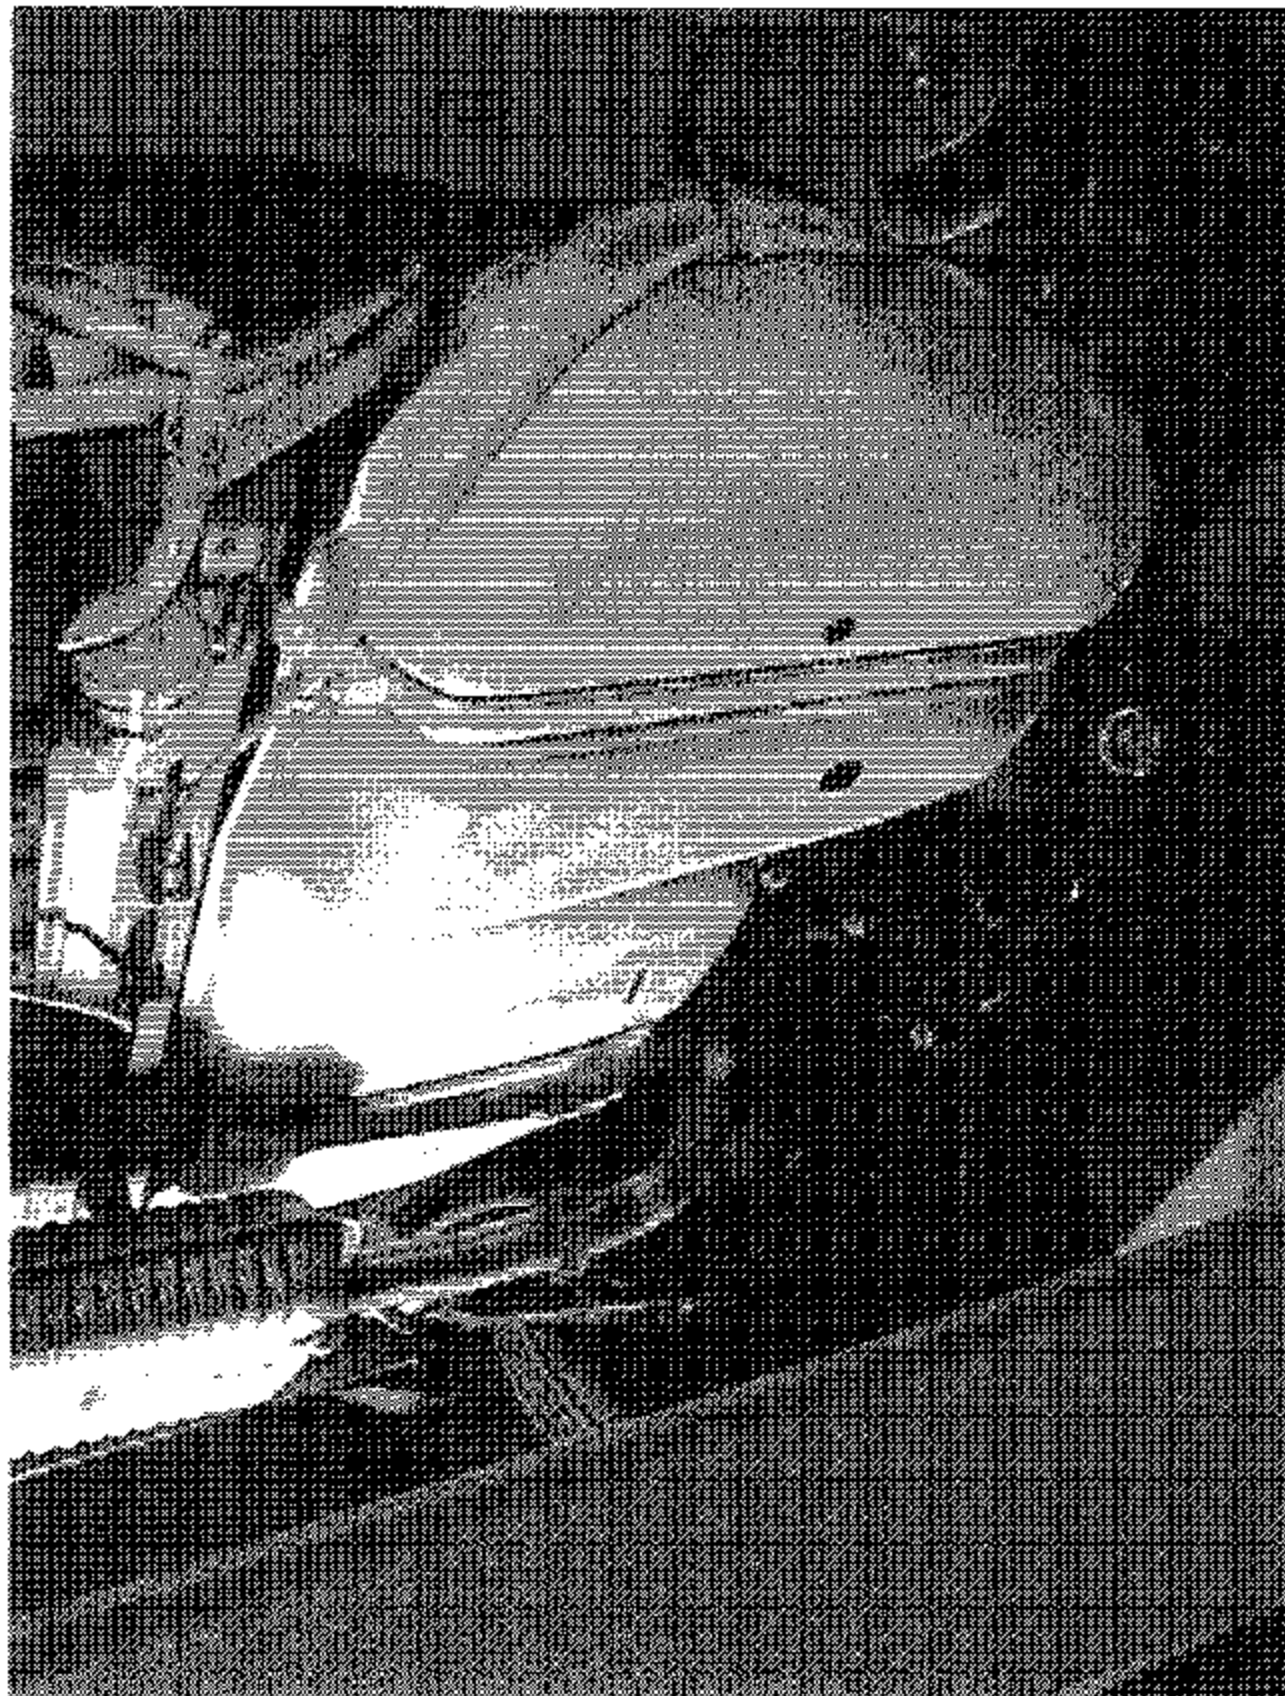
FIGURE 5.10
UNDERBODY VIEW OF FUEL TANK LEFT VIEW
PRE-TEST

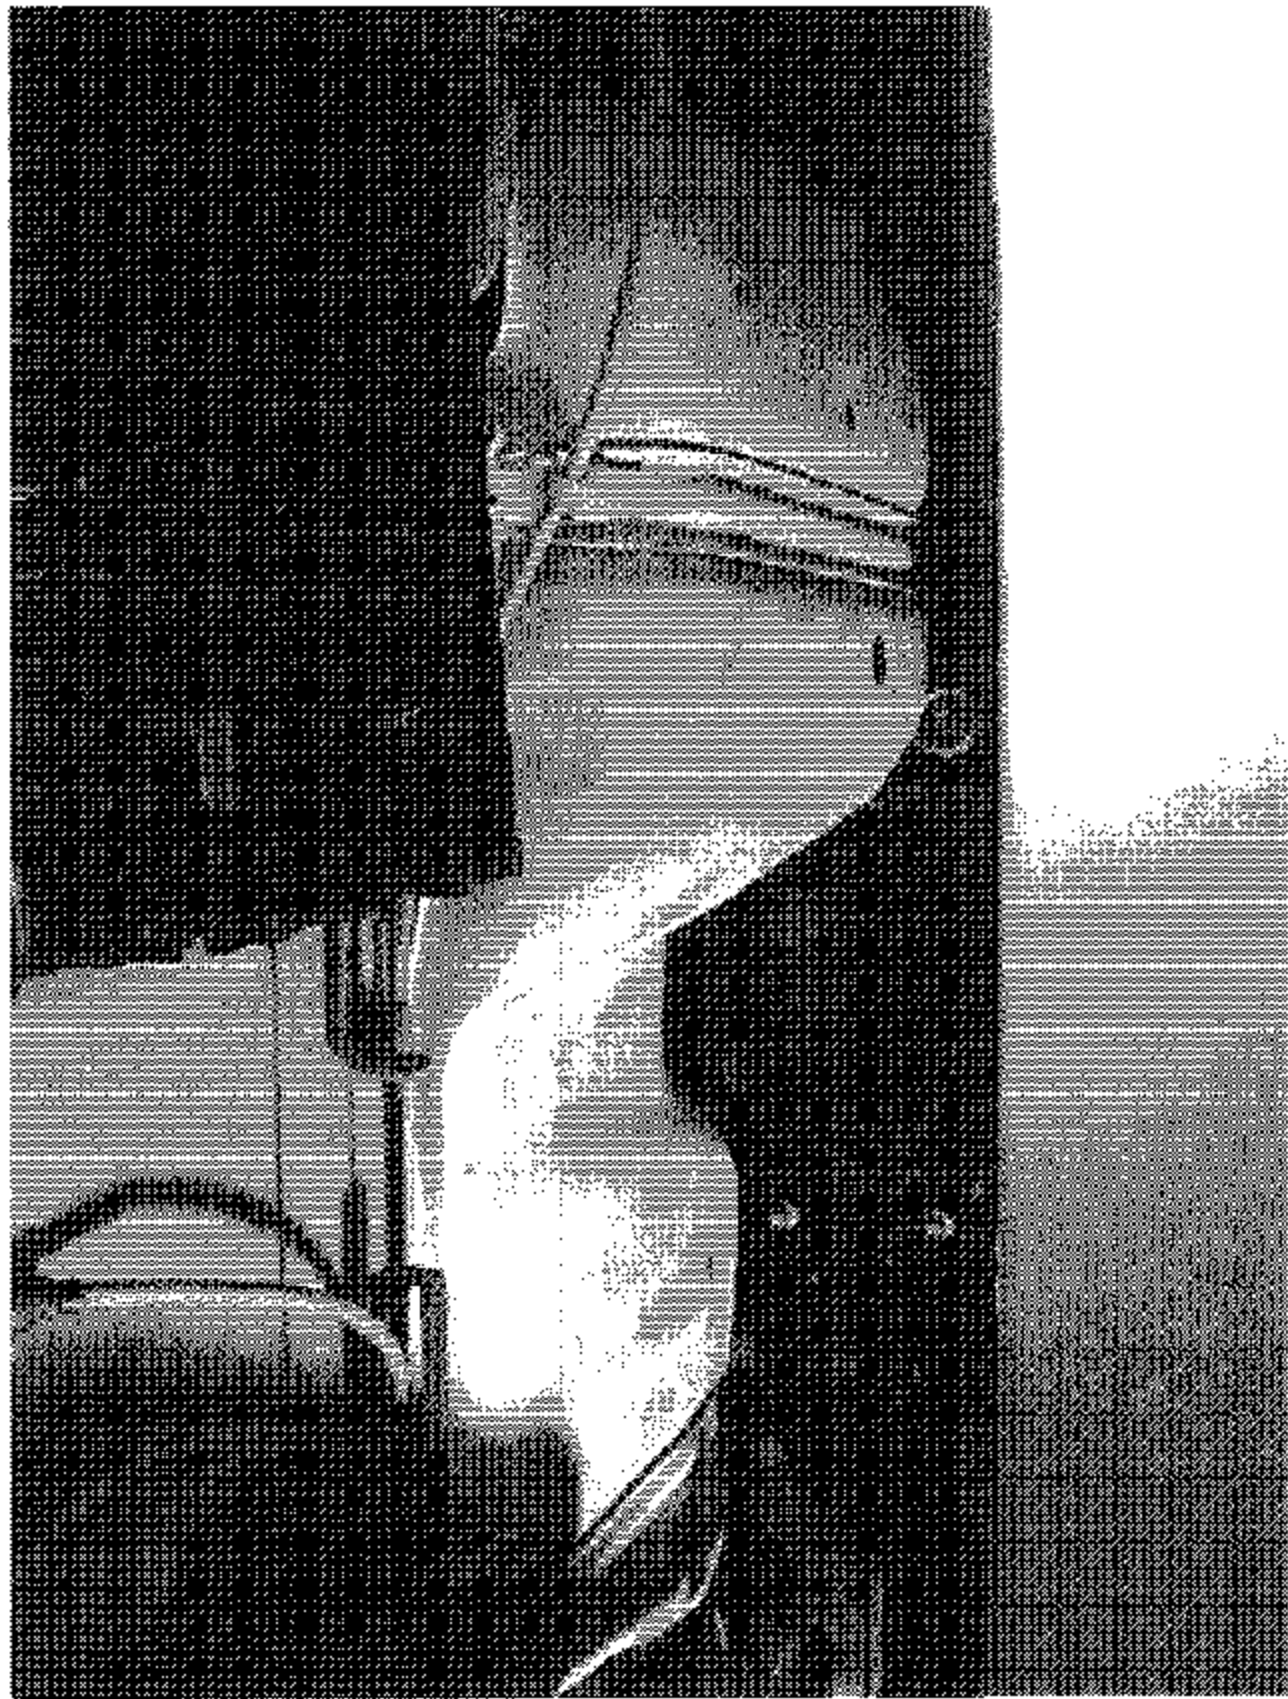
FIGURE 5.11
UNDERBODY VIEW OF FUEL TANK FRONT VIEW
PRE-TEST

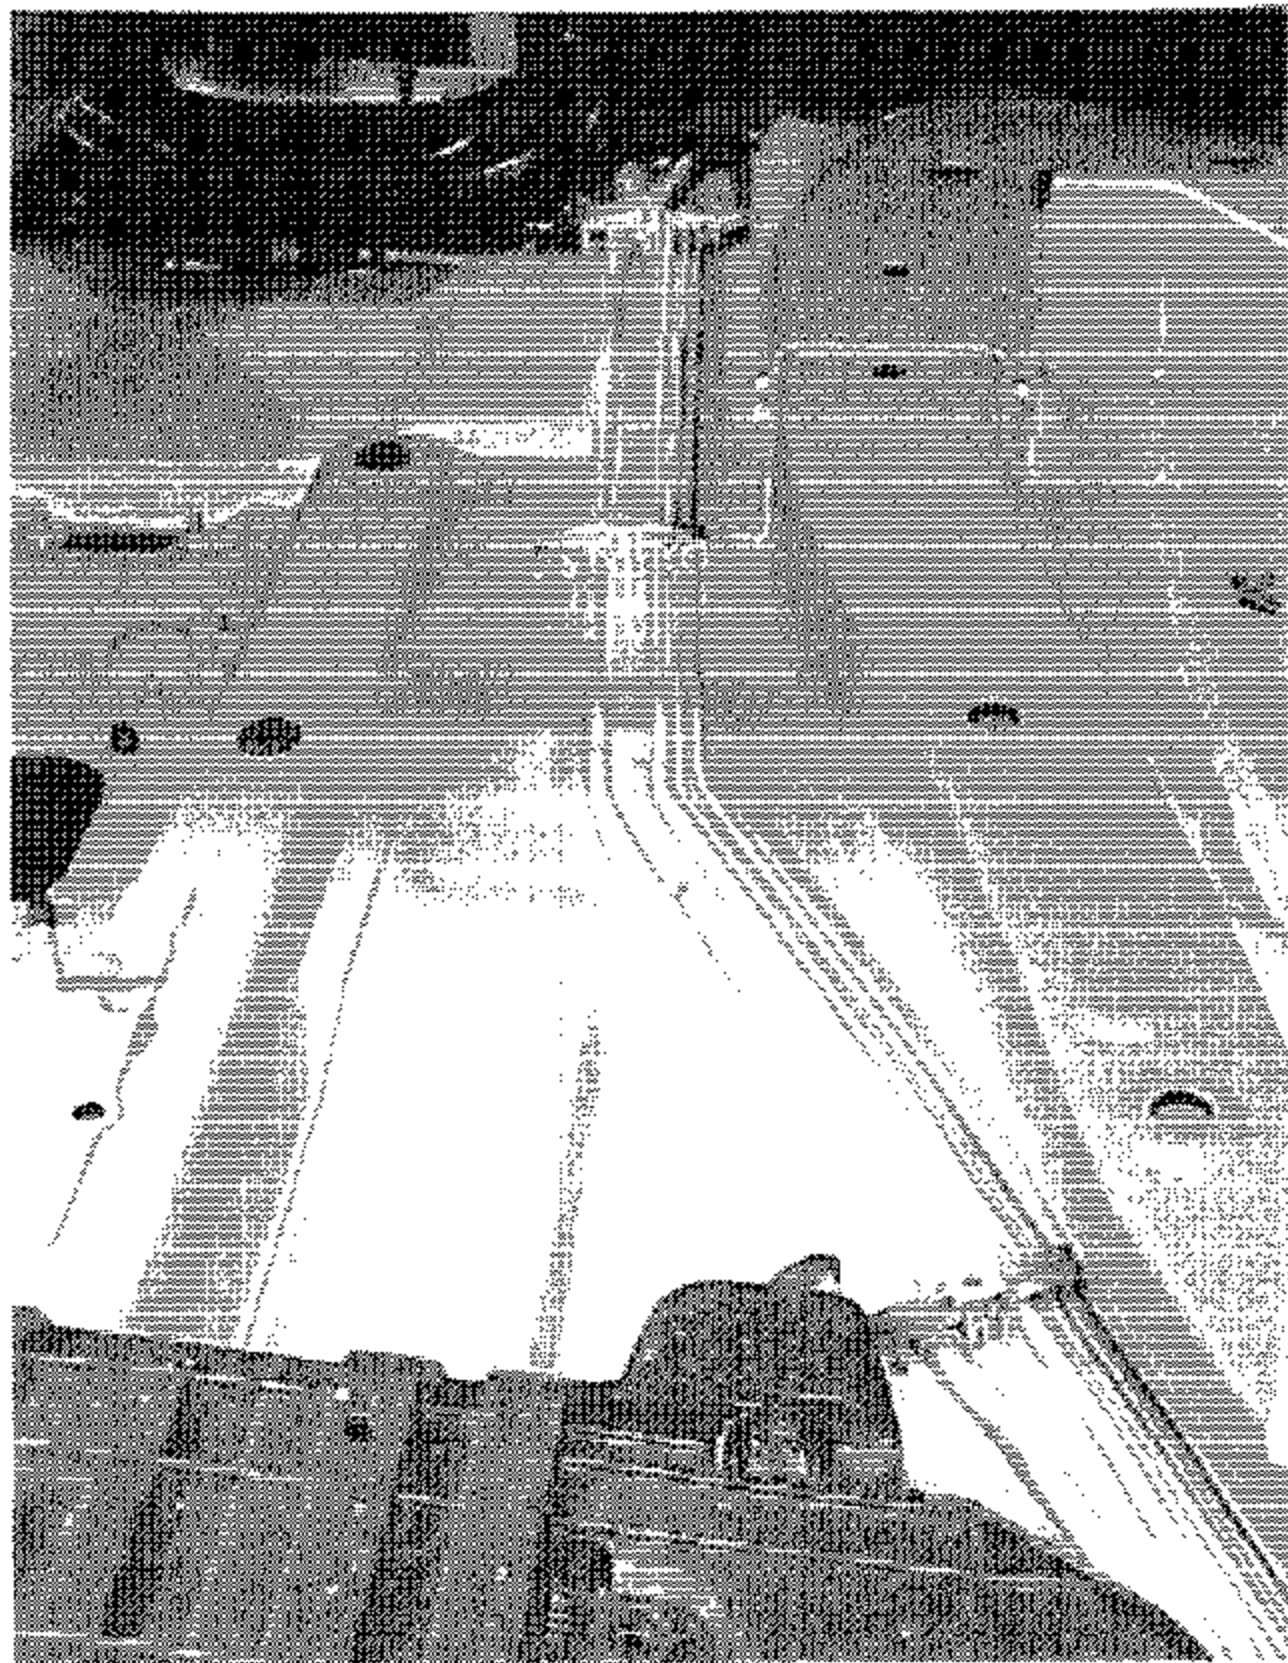
FIGURE 5.13
UNDERBODY VIEW OF FUEL LINES MID VIEW
PRE-TEST

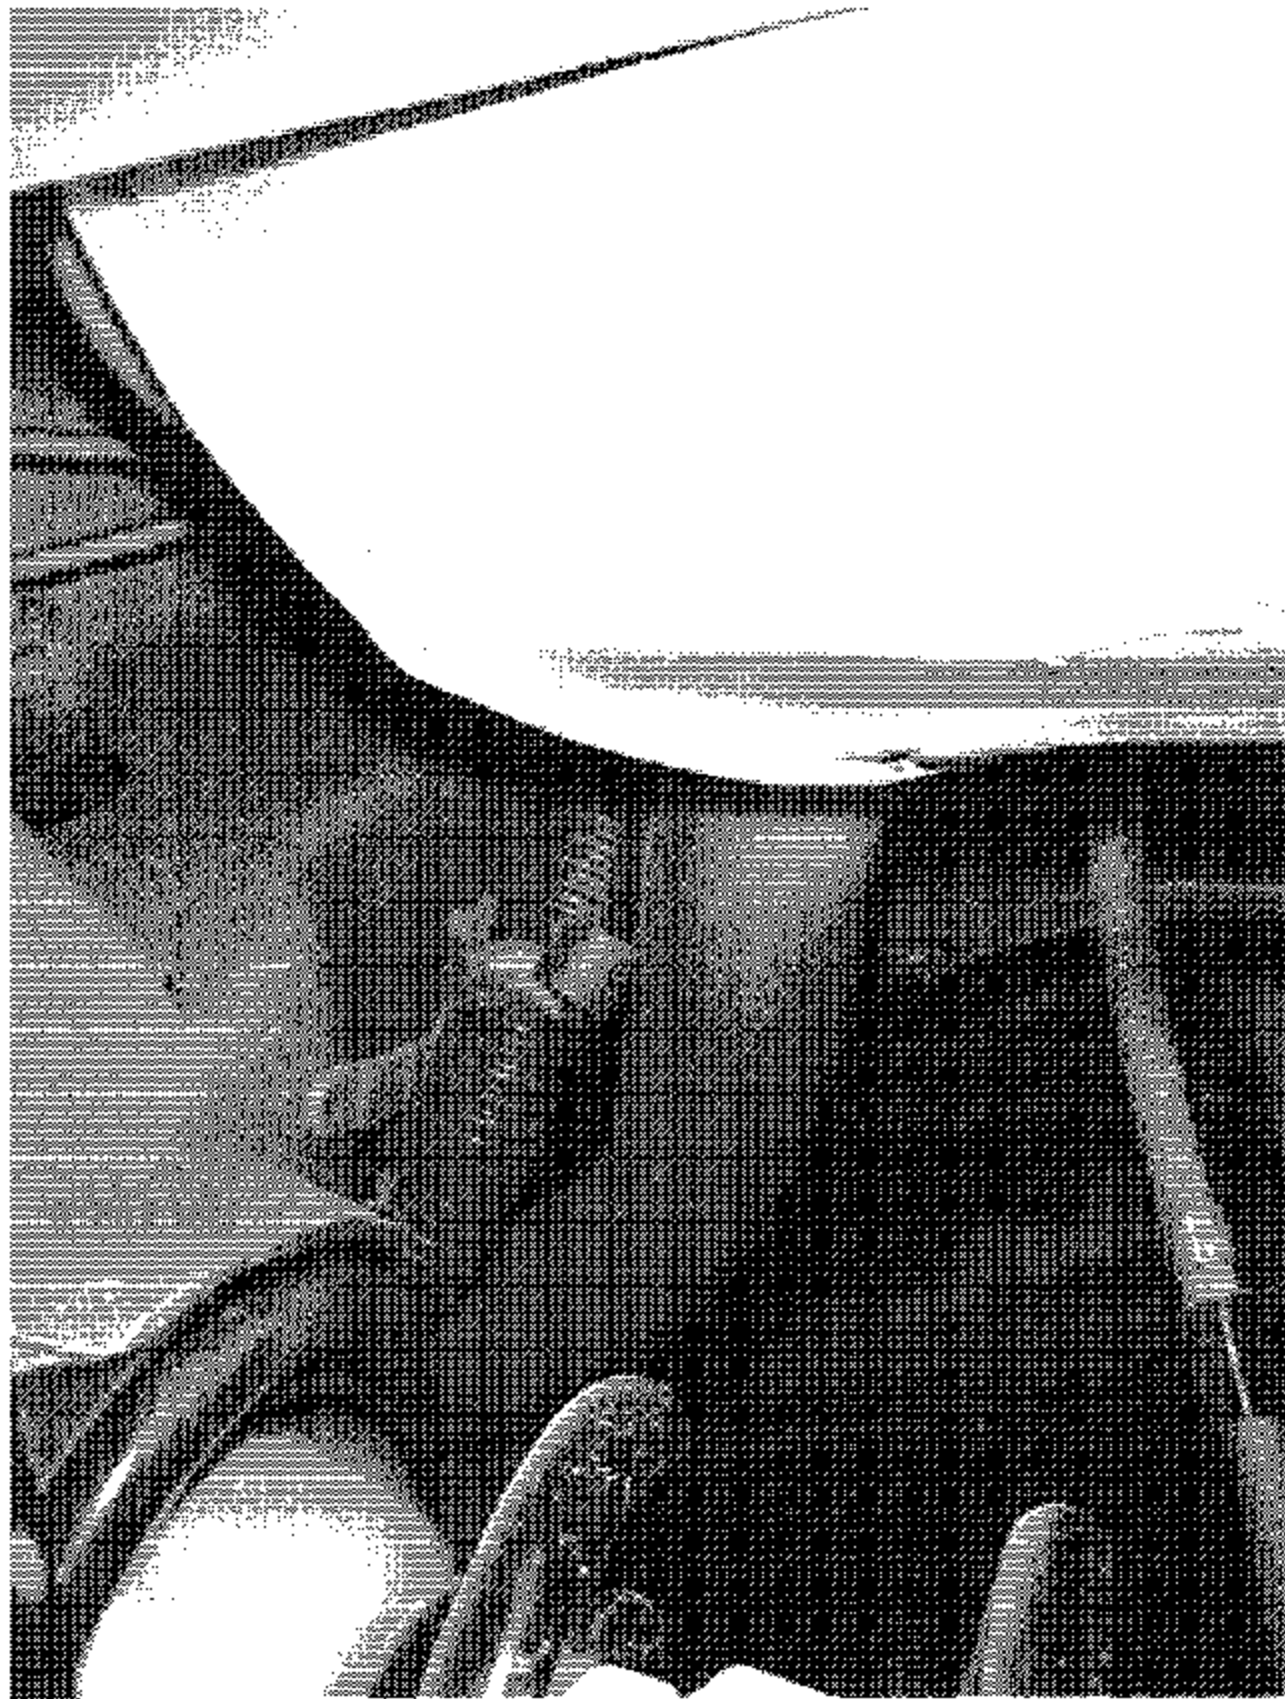
FIGURE 5.17
UNDERBODY VIEW OF FUEL FILL LINES AT TOP
PRE-TEST

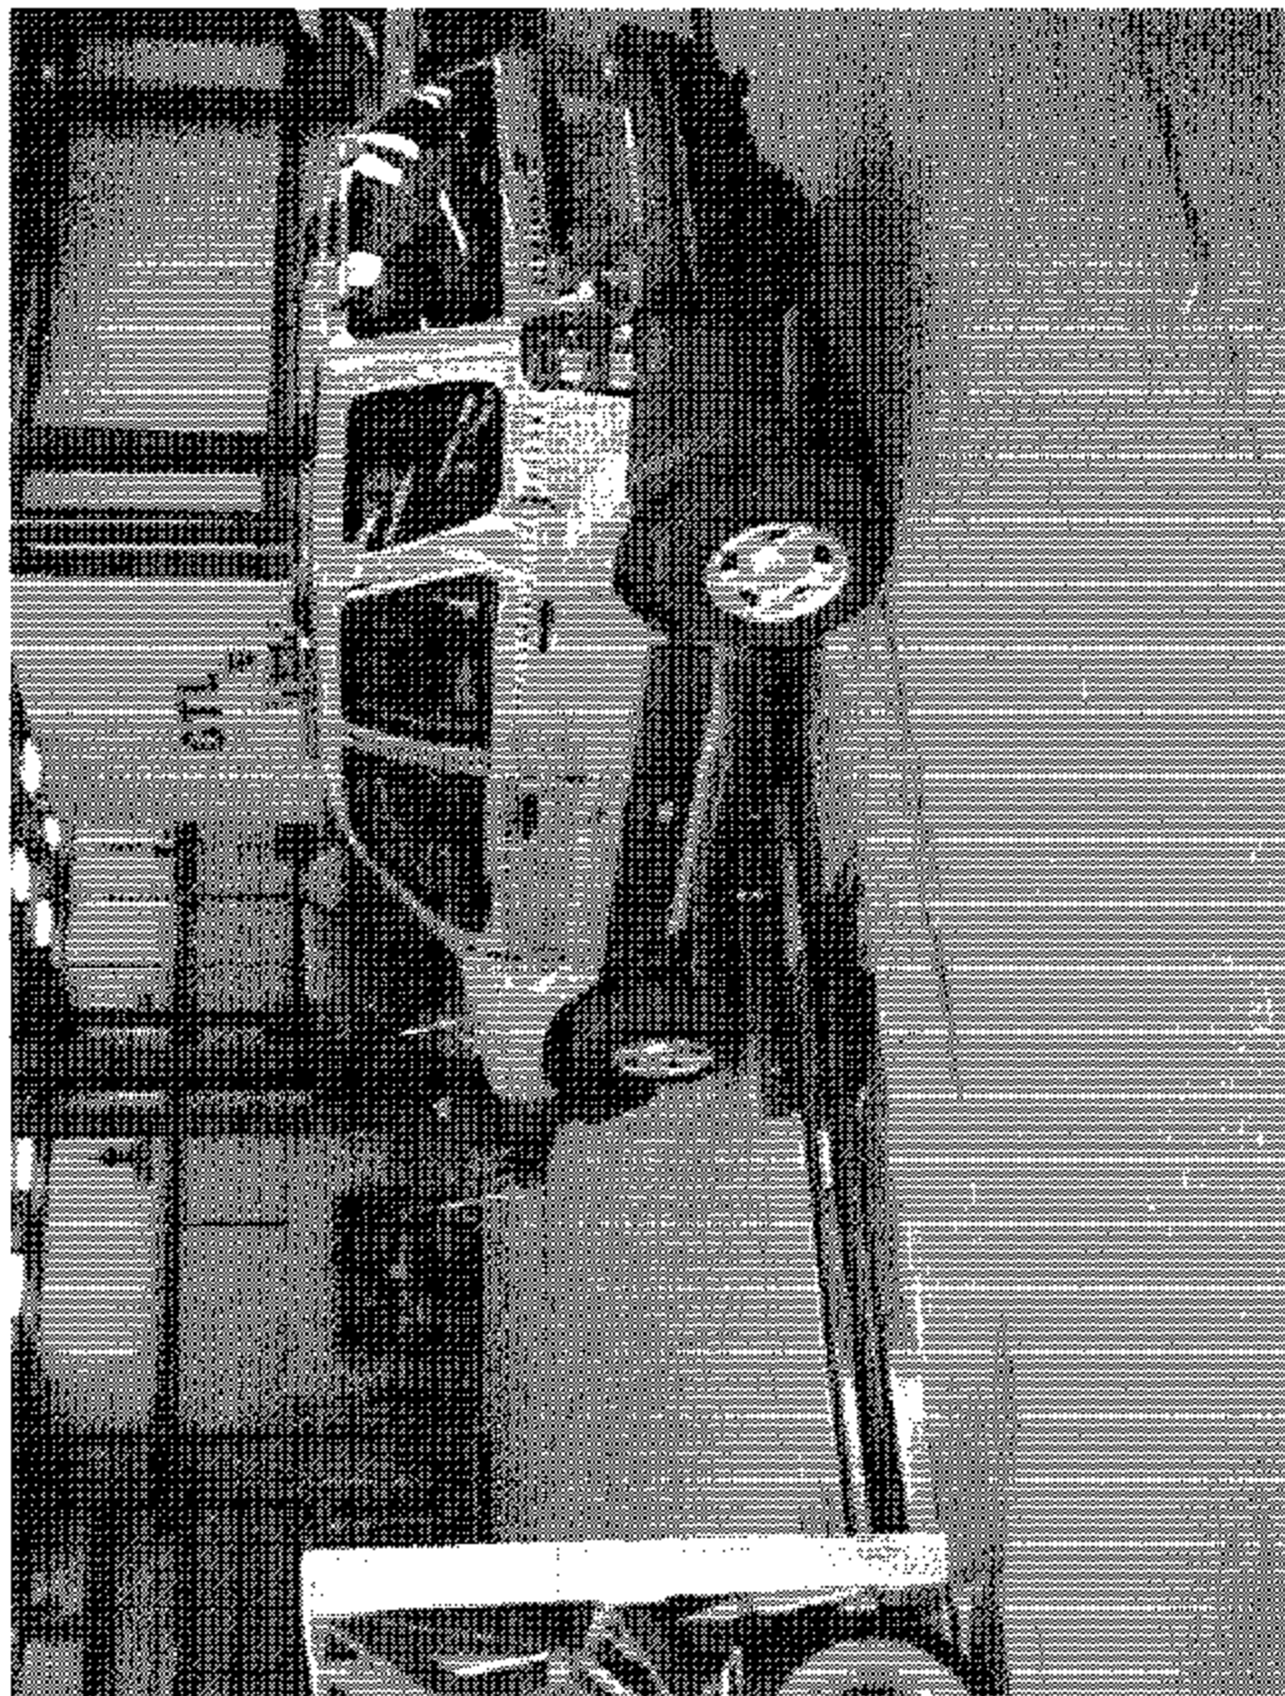
FIGURE 5.28
RIGHT VIEW OF VEHICLE/BARRIER POST TEST

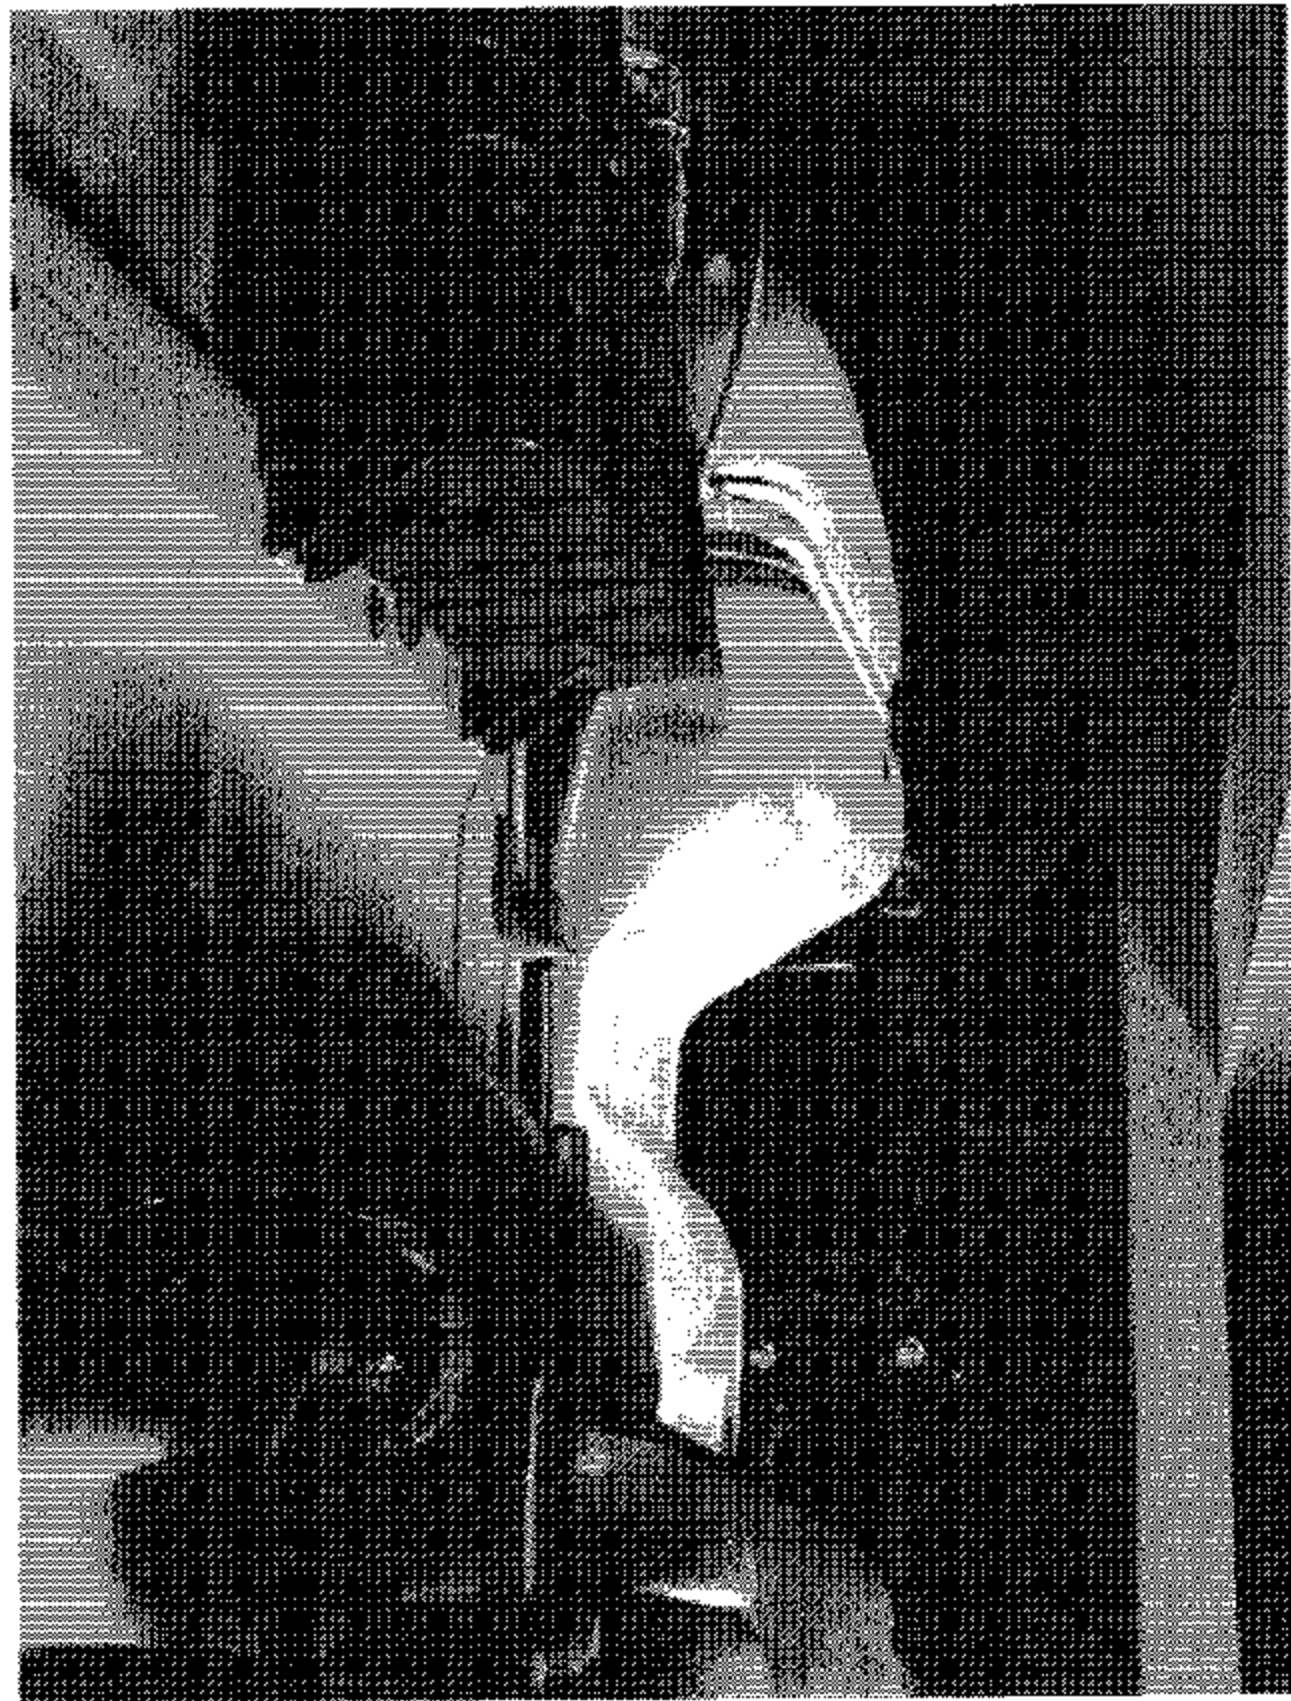
FIGURE 5.31
UNDERBODY VIEW OF FUEL TANK FRONT VIEW
POST TEST

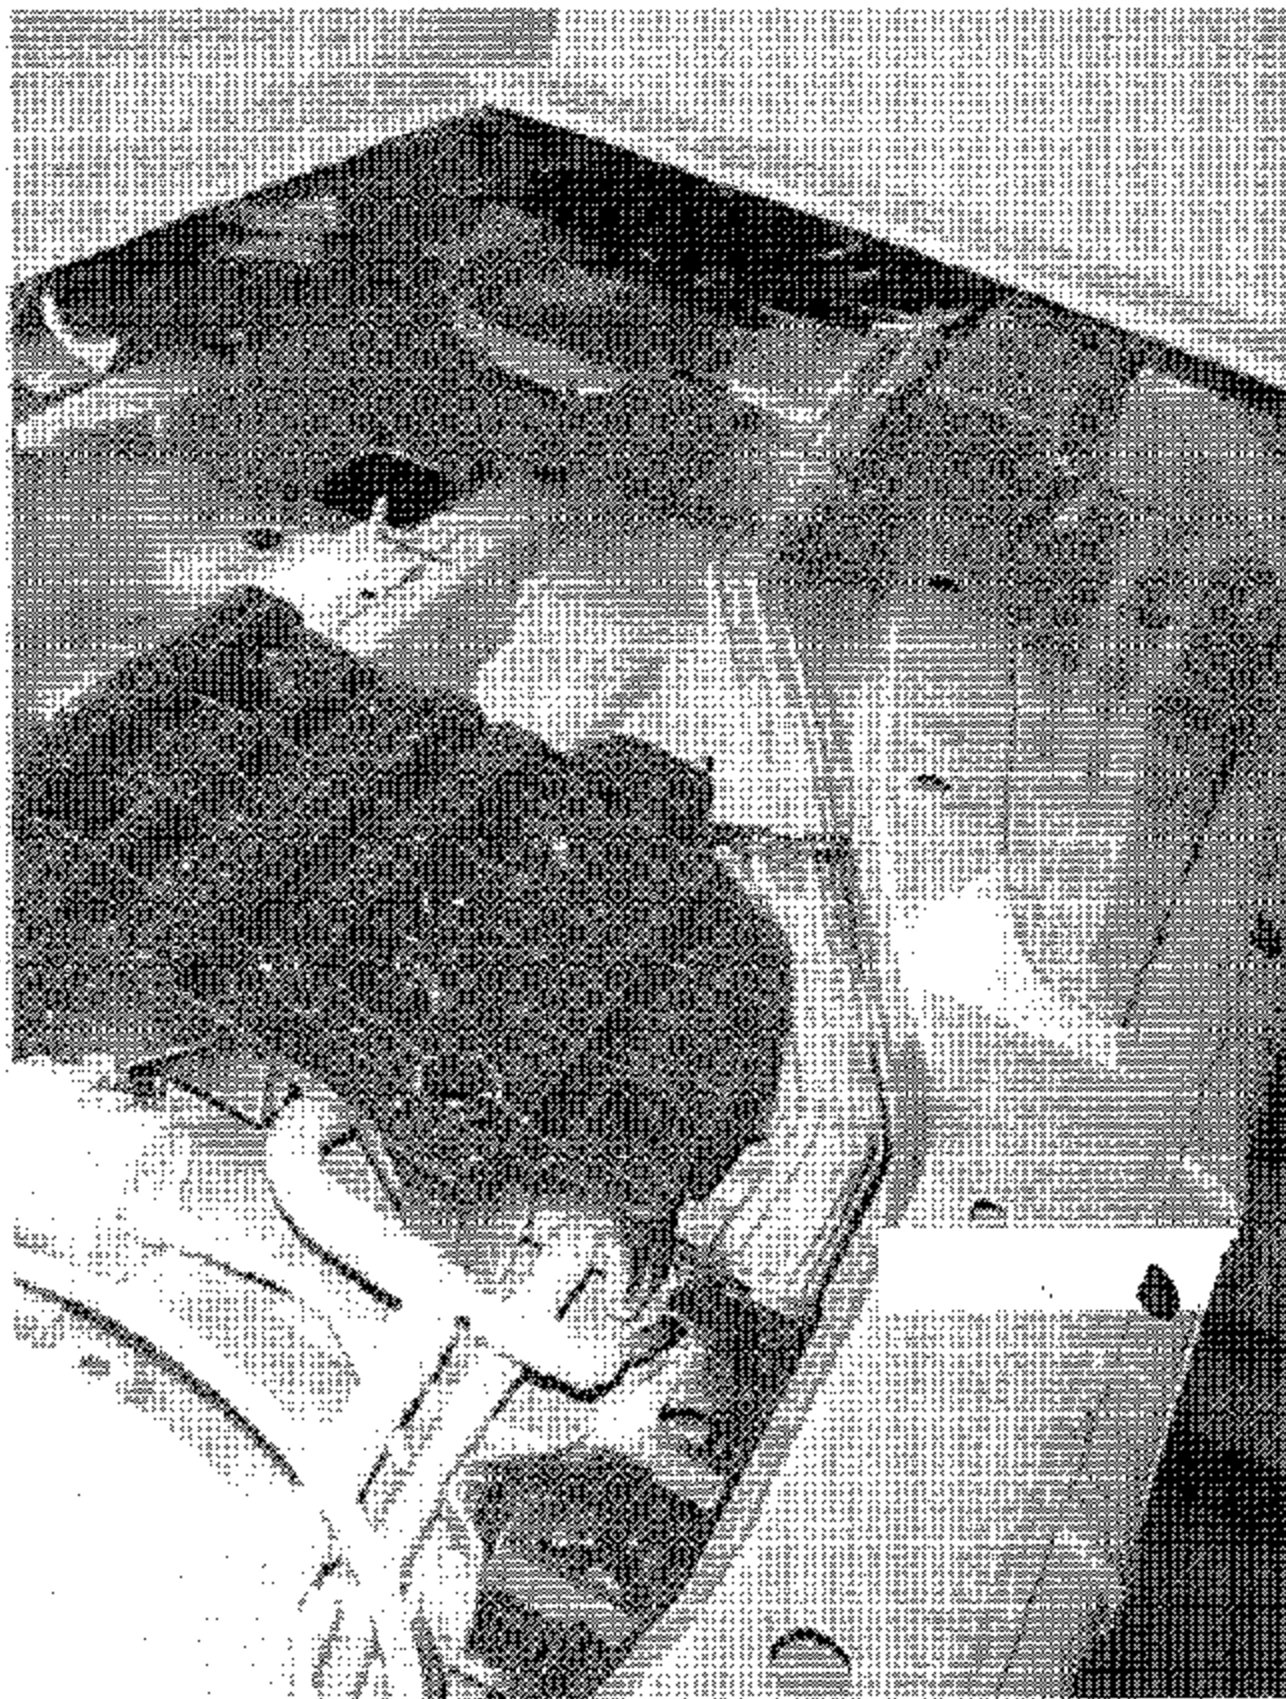
FIGURE 5.33
UNDERBODY VIEW OF FUEL LINES MID VIEW
POST TEST

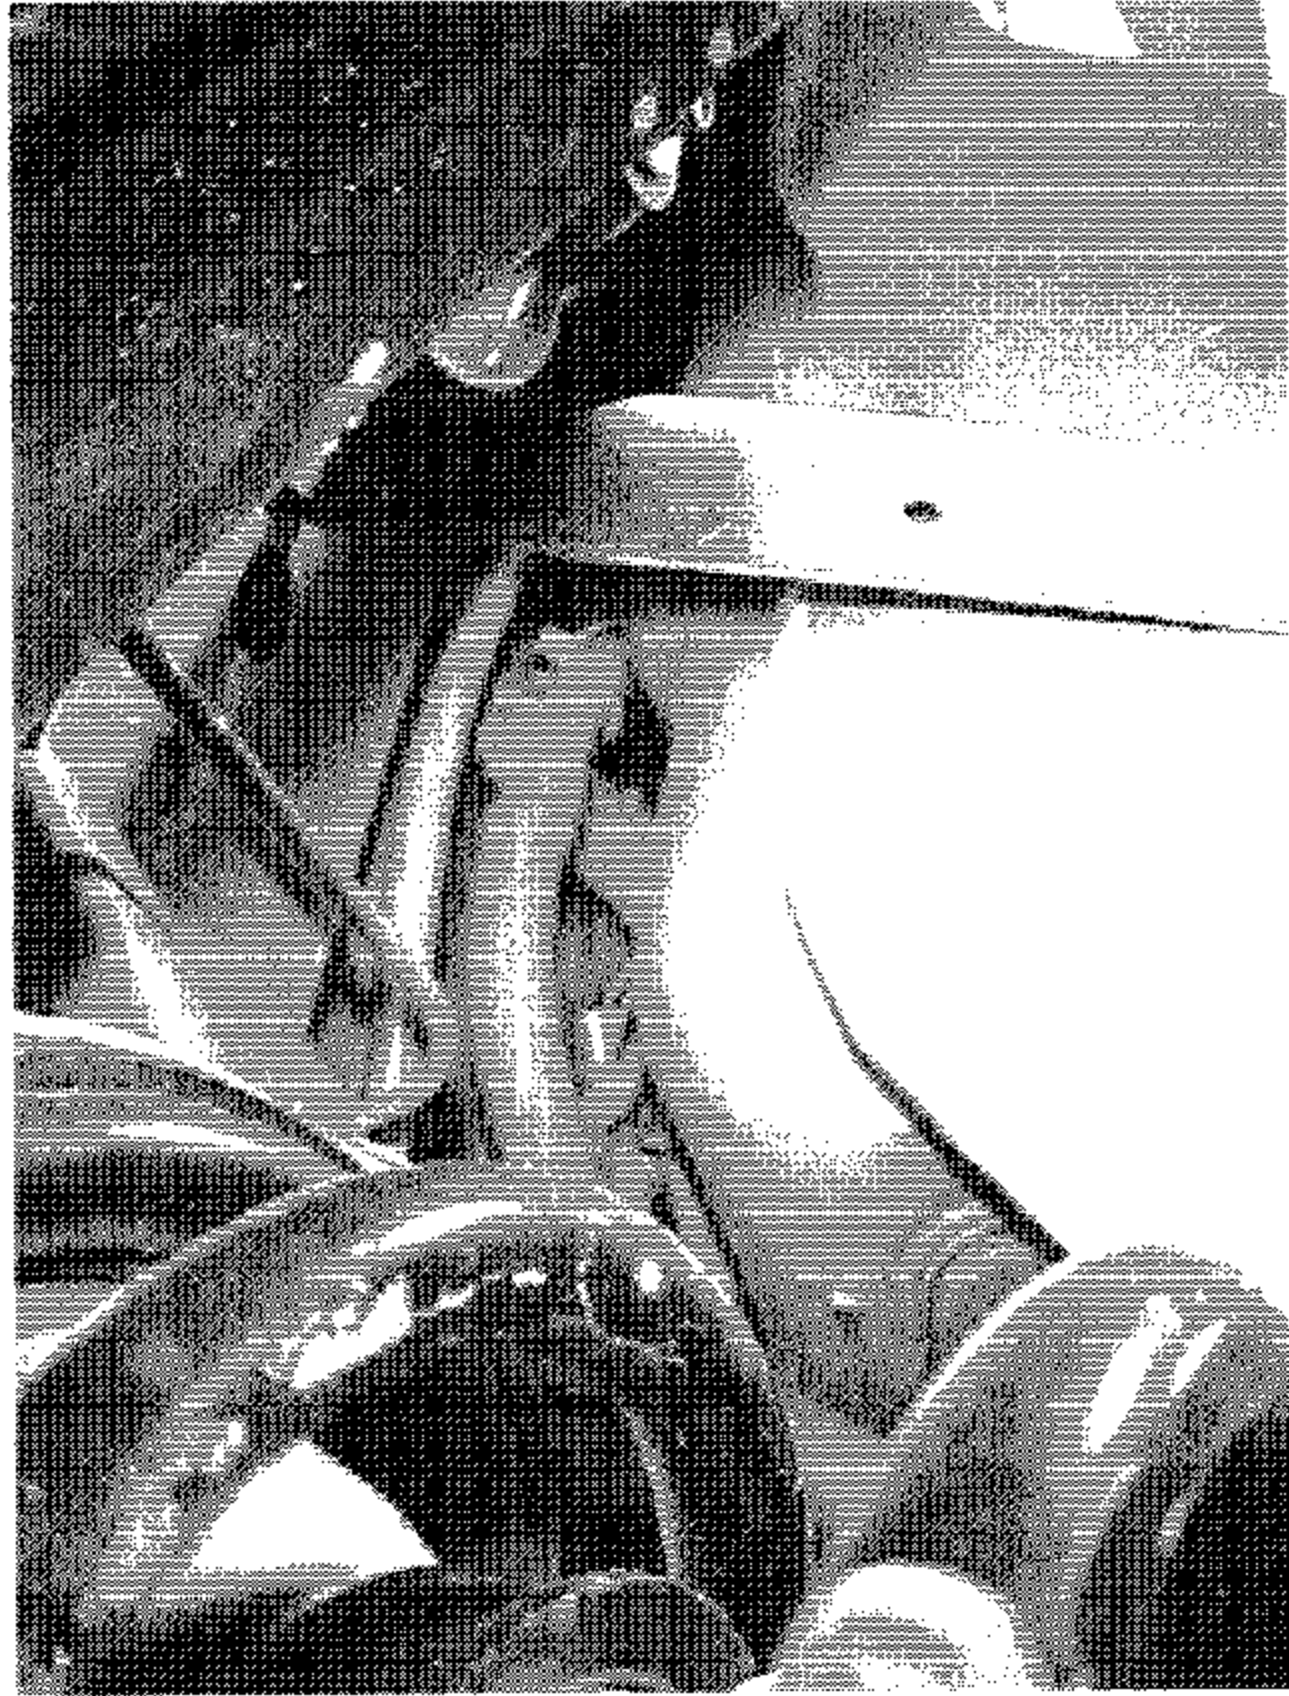
FIGURE 5.34
UNDERBODY VIEW OF FUEL LINES AT TANK
POST TEST

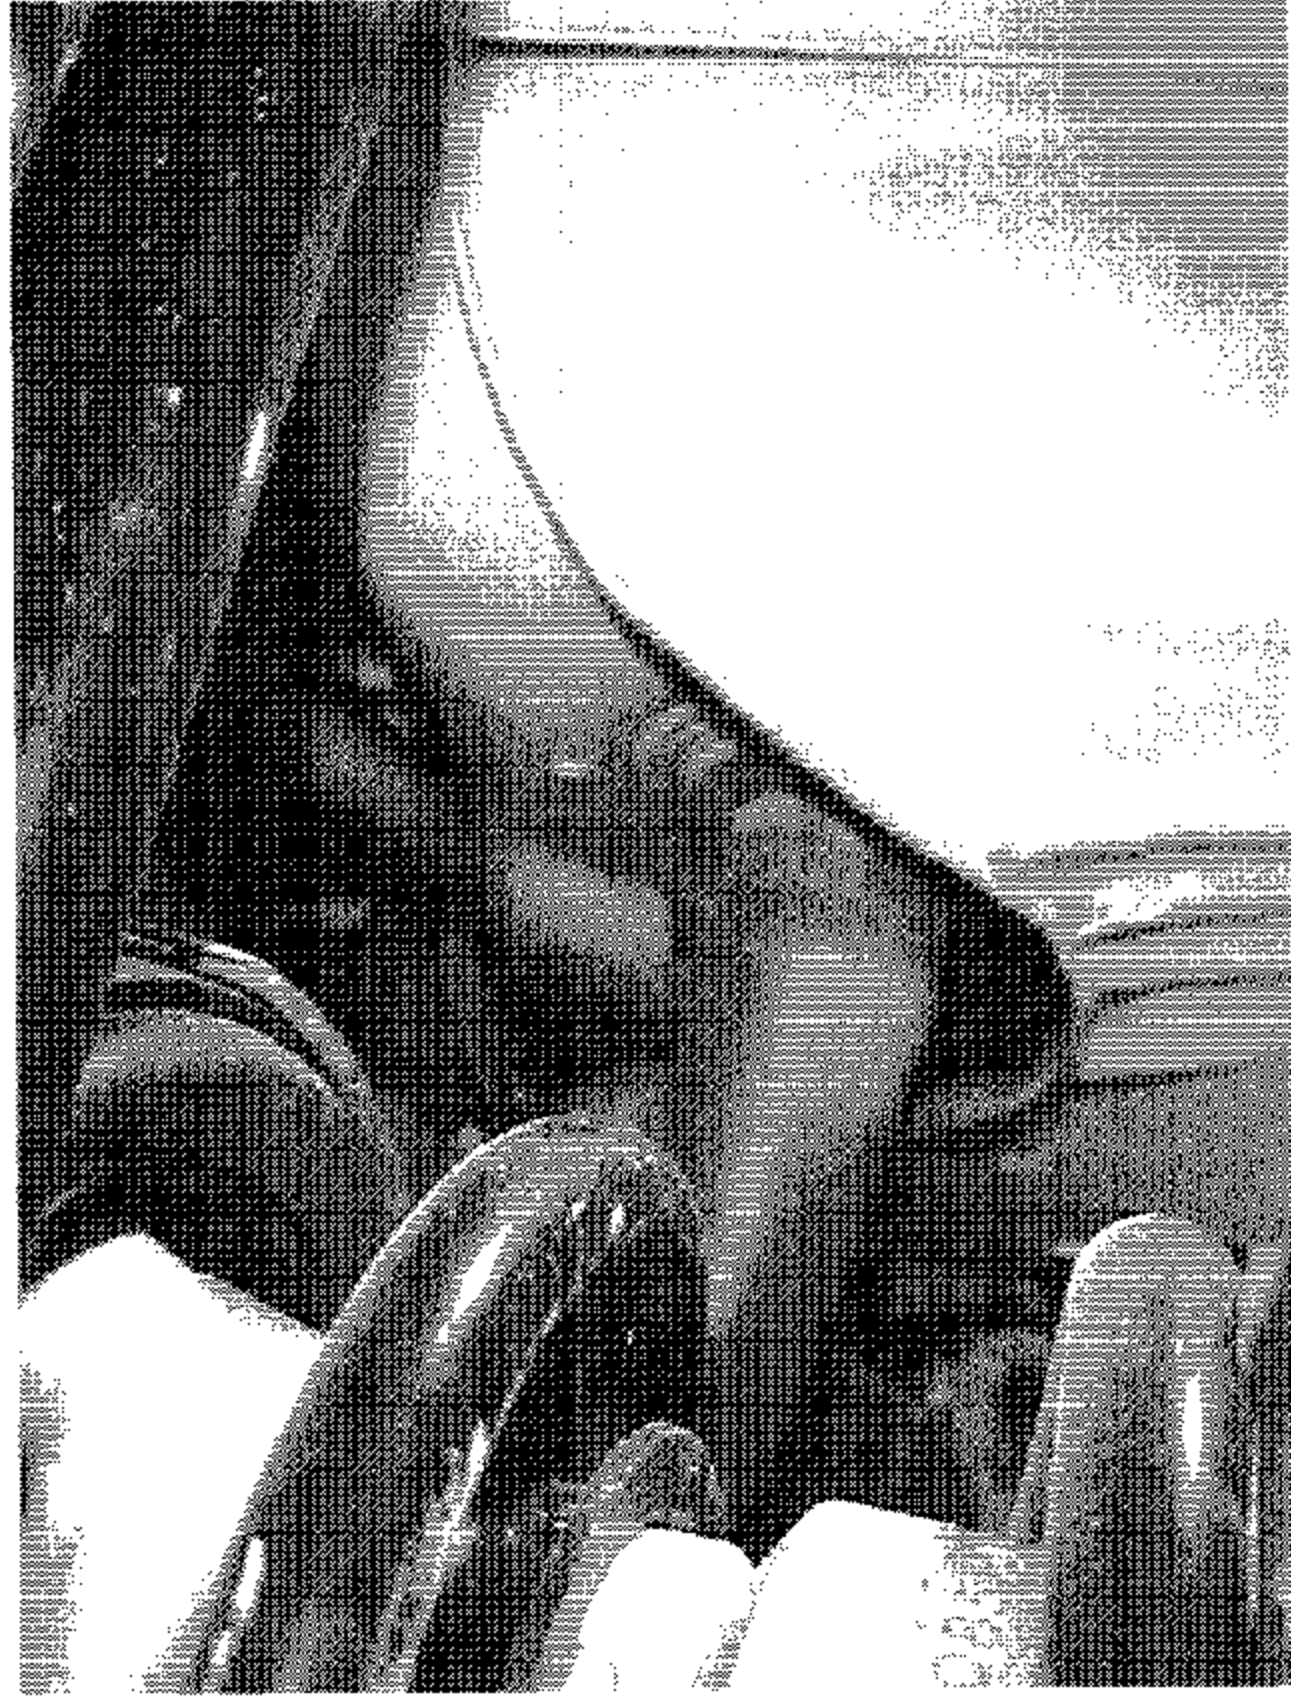
FIGURE 5.36
UNDERBODY VIEW OF FUEL FILL HOSE AT TANK
POST TEST
